# Landslide FE Stability Analysis

ABSTRACT: FE stability analysis of a landslide is carried out. Site investigation (SI) and laboratory testing are performed defining the soil conditions, which consist of firm to stiff silty clays, mudstones and sandstones. The water table (WT) is considered to vary from the surface of the mudstone/sandstone bottom layer, to the recently measured level. The sliding planes are defined and implemented in the analysis. For the considered WT conditions, residual friction angles  $\varphi_R = 12^\circ$  and  $\varphi_R = 15^\circ$  are respectively evaluated to be the minimum required for equilibrium. The measured values vary from  $\varphi_R = (10 - 14)^\circ$ . On these conditions engineering measures such as 4 rows of cast-in-place piles of diameter  $D=1.0$  m and spacing  $(2-3)*D$  in combination with the drainage system, are analysed as a measure to stabilize the landslide.

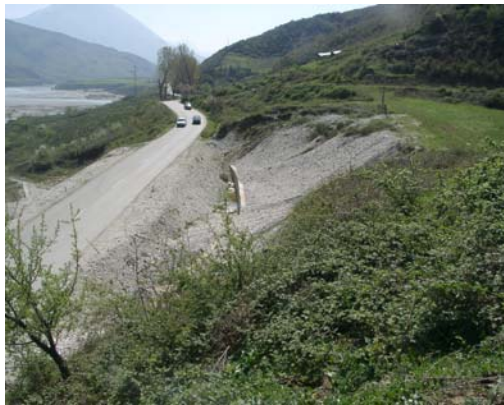
Figure 1. (a) The central part of the sliding zones (b) The downfall part seen from the upper part.

The landslide is located on the left side of the Vjosa River in Albania. The inclination of the valley is different at different levels and is conditioned from the geological formation. The parts composed of sandstones are steeper than the parts composed of mudstones. Different parts of the zone are shown in Figure 1. The incline is afforested with small plants mainly bushes. Some almost horizontal parts exist created by Vjosa River representing the old terraces. The inclination is composed of mudstone and sandstone covered by 5-10 m colluviums deposits.

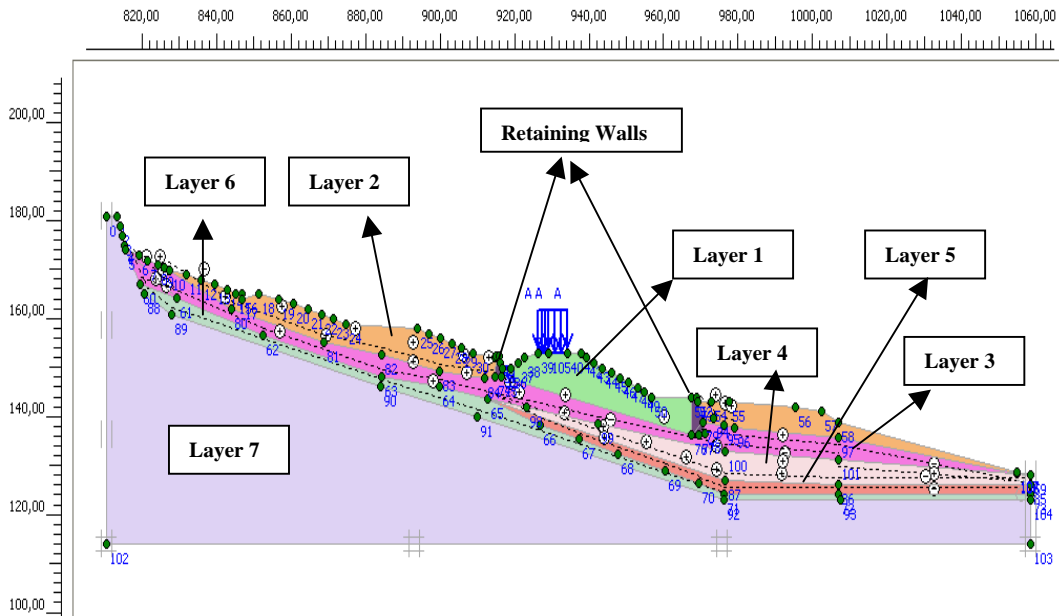
The analysis is carried out with PLAXIS FE program, (PLAXIS, 2002) It is important for the stability of the slope to model the section to the lowest quotes reached at the river flow. Two-dimensional (2D), plane strain FE modelling is carried out as shown in Fig. 2 where the dimensions are in meters giving the real geometry of the considered most critical section.

Fixed boundary conditions are applied at the bottom of the FE model considering no deformations to occur at that depth of Layer 7. On the left side the model is terminated at the start of the Layer 7 and on the right side at the lowest quote assuming zero horizontal deformations to occur. This might be rather optimistic considering the erosion effect from the river flow.

The traffic load is modelled as uniformly distributed vertical load according to (DS410E, 1998) as shown in Fig. 2. The dynamic effects from the traffic or seismic activity are not taken into account. in the current analysis.

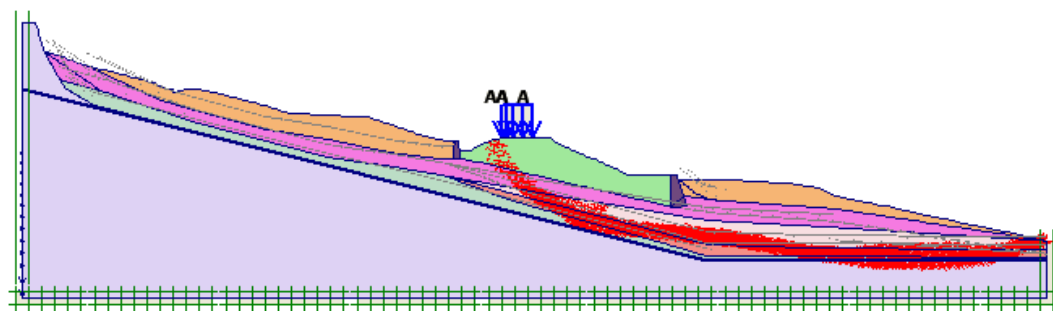
a)

Extreme principal strain increment  $-29,07 \cdot 10^{-3} \%$

Figure 3. Failure mechanisms for deactivated sliding planes. (a) Low WT (b) High WT.

Firstly, the FE calculations of the model deactivating the sliding planes, are carried out. The results of the calculations consisting of the failure mechanisms are given in Fig. 3 (Incremental Strains) for low and high WT.

Ignoring the sliding planes  $F_s$  varies from 1,77 to 2,15 and 1,39 to 1,73 respectively for low and high WT and characteristic and design soil parameters. Regarding the failure mechanisms, rotational slip is found for low WT and successive slips for high WT, cf. Fig. 3.

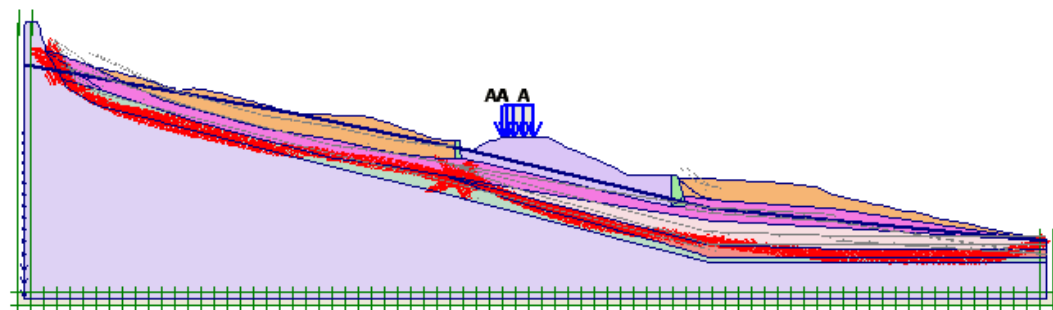
b)

Extreme principal strain increment  $-7,62 \cdot 10^{-3} \%$

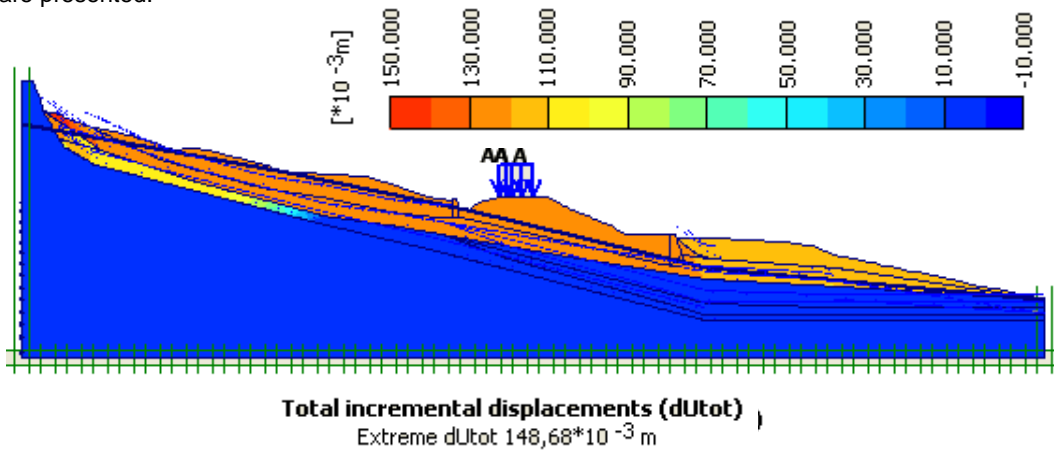
Figure 4. Failure mechanism, active sliding planes,  $\phi_R = 15^\circ$ , high WT.

The results of the stability calculations considering active sliding planes are given in Fig. 4, (incremental displacements). Only the results from the models with interface soil properties modelled with the friction angle equal to the minimum required residual value and zero cohesion, are presented.

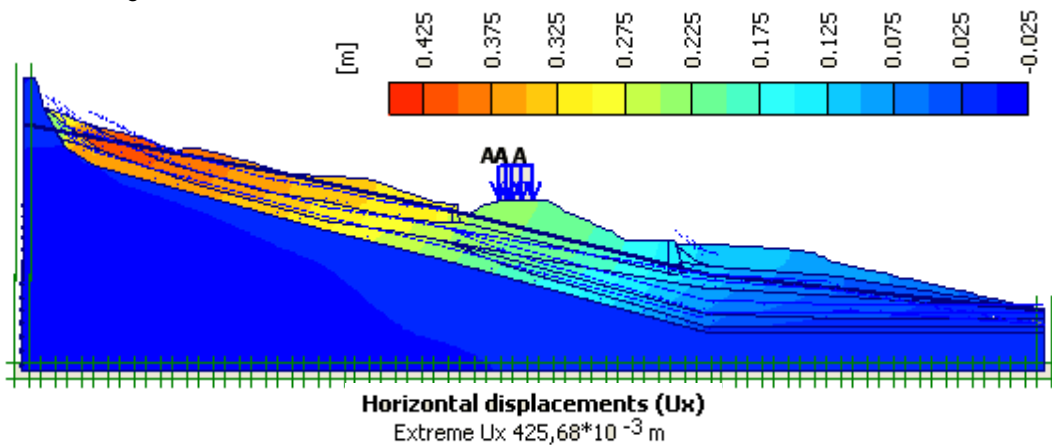
Figure 5. Horizontal deformations, active sliding planes  $\phi_R = 15^\circ$ , high WT.

Sensitivity analyses are carried out assuming a higher interface friction angle than measured and shown in Table 1 and reducing it to the minimum value required for equilibrium. For low WT residual  $\phi_R = 12^\circ$  and for high WT  $\phi_R = 15^\circ$ , characteristic values, are evaluated to be the minimum required for equilibrium. In Fig. 4 the failure mechanism is given for high WT and residual  $\phi_R = 15^\circ$ . Horizontal deformations of (45 - 50) cm are observed at the head of the sliding zone in this case, as shown in Fig. 5.

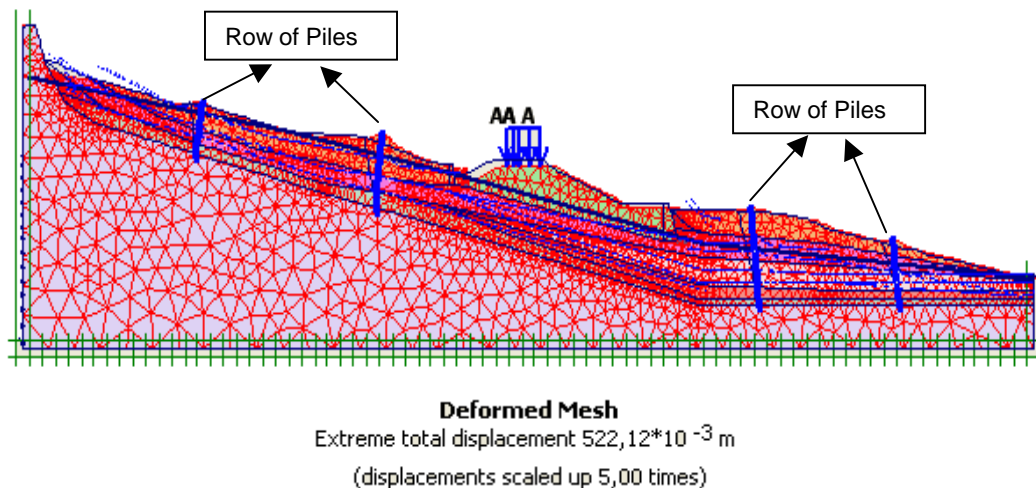
Figure 6. Deformed mesh. Landslide stabilized by 4 rows of cast-in-place piles.

Four rows of concrete cast-in-place inclined piles of  $D=1.0$  m and (2-3)D spacing, long enough to reach Layer 7 and in-caster minimum 1.0 m at this layer, are applied as shown in Fig. 6 in combination with the drainage system, which maintains the WT at the measured level. Plate elements are employed to model the row of piles in the out-of-plane direction taking into account the pile dimensions, material and pile spacing. The piles behave elastically. The 3D effect will be investigated in a further investigation considering 3D FE modelling.

piles are shown in Fig. 6, deformed model, and Fig. 7 failure mechanism. The analysis is carried out with design parameters (including partial coefficients) for soil layers and the interface or sliding planes. The measured WT is maintained due to drainage system. Safety factor  $F_s > 1.0$  is calculated for the stabilized landslide.

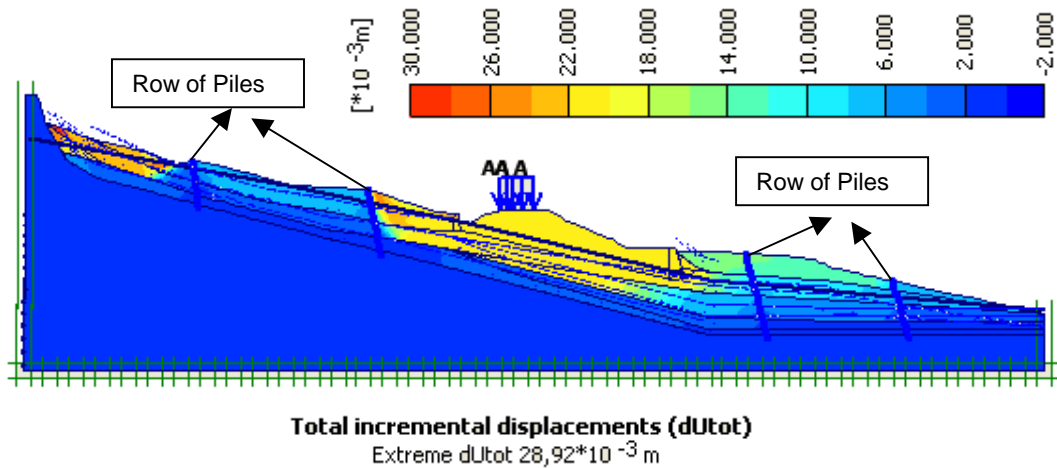
Figure 7. Failure mechanism. Landslide stabilized by 4 rows of cast-in-place piles.
